# INDOOR AIR QUALITY ASSESSMENT

**Lexington Town Hall  
1265 Massachusetts Avenue  
Lexington, Massachusetts**

Prepared by:  
Massachusetts Department of Public Health  
Center for Environmental Health  
Emergency Response/Indoor Air Quality Program  
April 2006

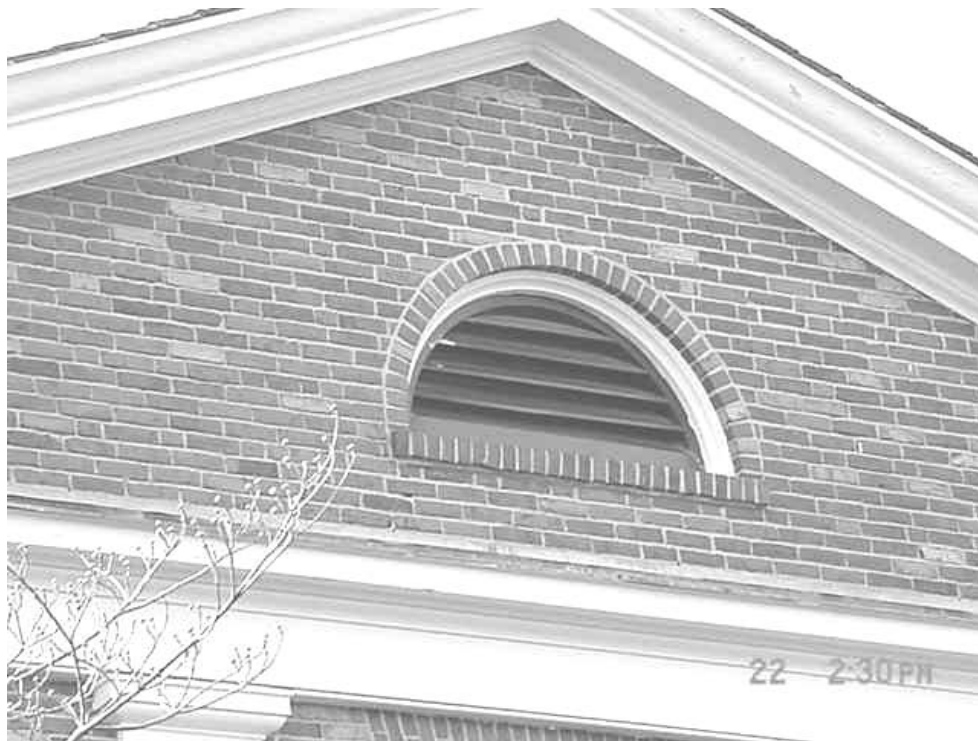
**Picture 1**

Mechanical ventilation is provided by two air-handling units (AHUs) located in the attic. Fresh air is drawn into the AHUs through an air intake located on the exterior of the building (Picture 1) and delivered to occupied areas via ceiling-mounted air diffusers (Picture 2). Return air is drawn into ceiling-mounted vents and ducted back to the AHUs. These systems were deactivated during the assessment.

**Fresh Air Intake for HVAC System**

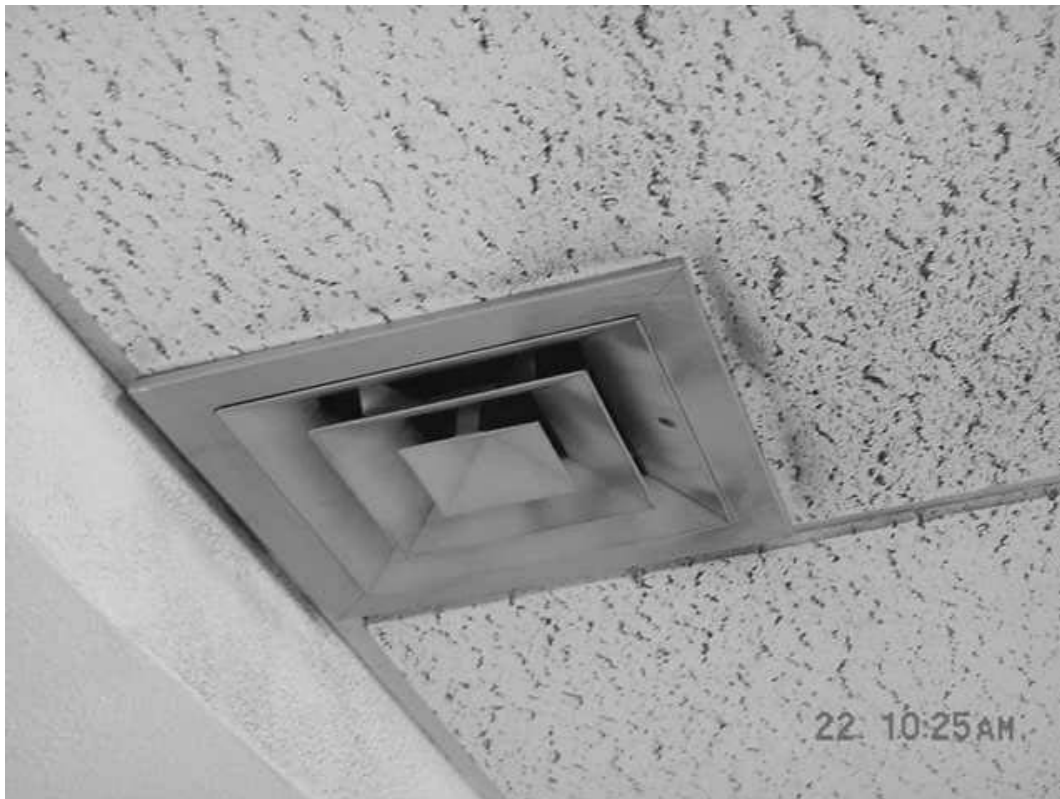
**Picture 2**

**Ceiling-Mounted Air Diffuser, Note Dust Accumulation on Diffuser and Ceiling Tiles**

22. Clean air diffusers, FCU return vents, personal fans and exhaust vents periodically of accumulated dust.
23. Consider cleaning carpeting annually (or semi-annually in soiled high traffic areas) as per the recommendations of the Institute of Inspection, Cleaning and Restoration Certification (IICRC). Copies of the IICRC fact sheet can be downloaded at:  
[http://www.cleancareseminars.com/carpet\\_cleaning\\_faq4.htm](http://www.cleancareseminars.com/carpet_cleaning_faq4.htm) (IICRC, 2005)
24. For further building-wide evaluations and advice on maintaining public buildings, see the resource manual and other related indoor air quality documents located on the MDPH's website at [http://mass.gov/dph/indoor\\_air](http://mass.gov/dph/indoor_air).

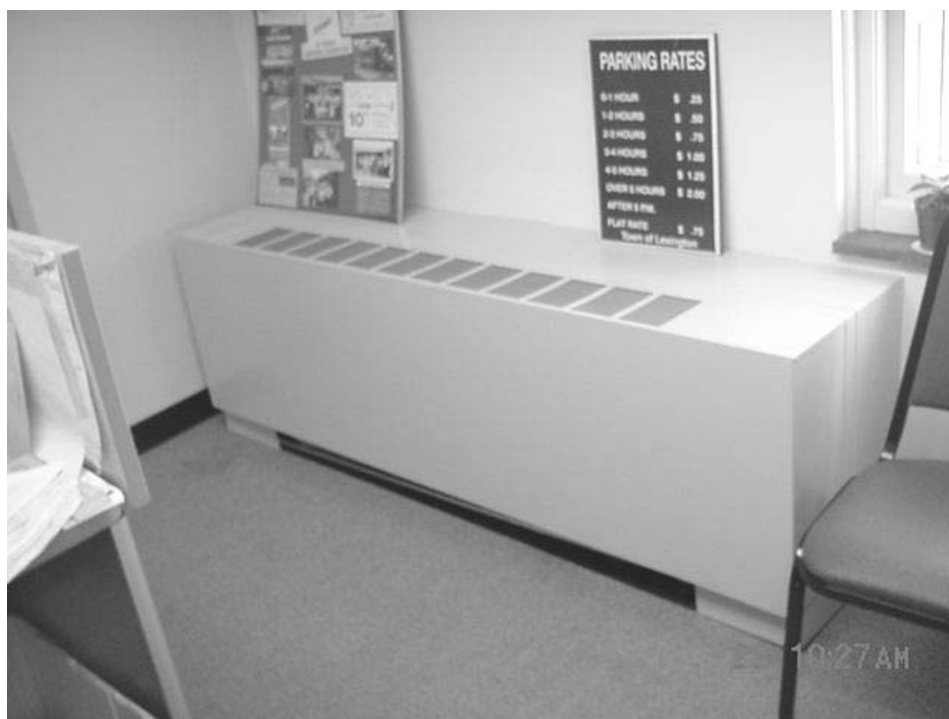
**Picture 3**

Fan coil units (FCUs) located along perimeter walls (Picture 3/[Figure 1](#)) provide supplemental heating or cooling as needed for each room. However, FCUs do not have the capability to introduce outside air; rather they re-circulate air. These units were deactivated in the majority of areas surveyed during the assessment. A number of FCU air

**Fan Coil Unit**

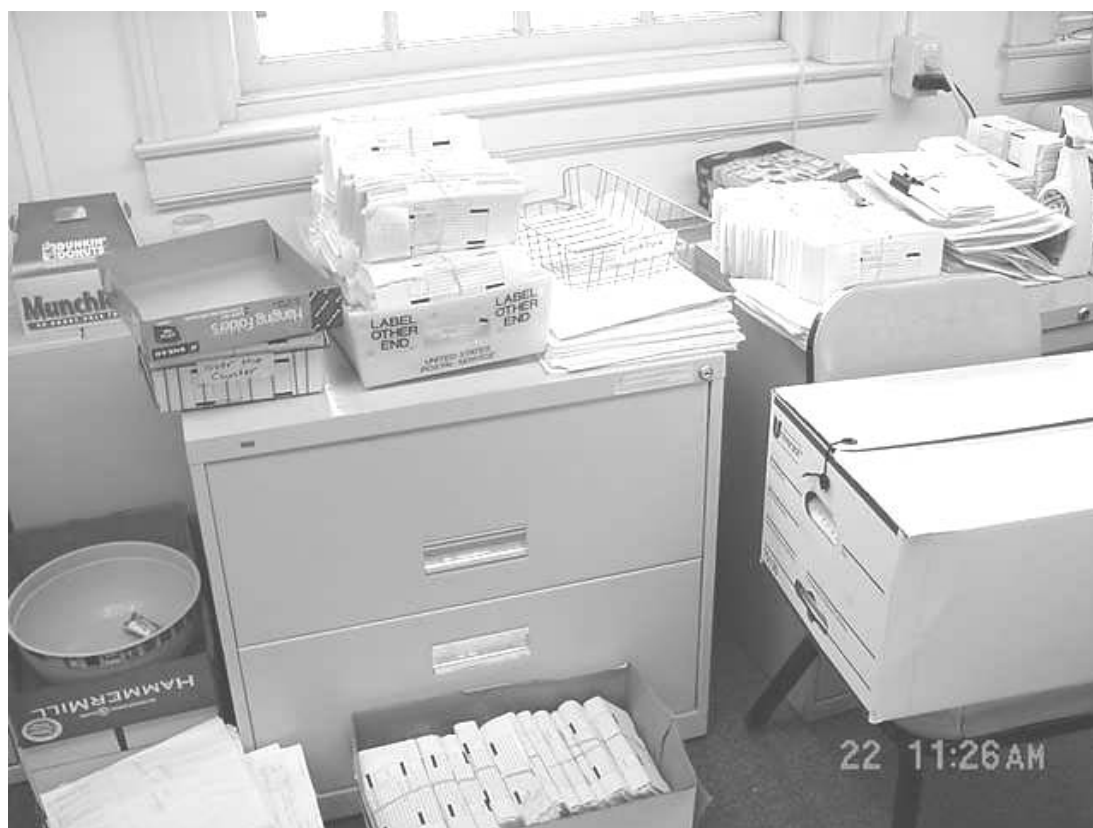
**Picture 4**

diffusers and/or return vents throughout the building were obstructed by various items, which limits air circulation.

**Various Items on and in front of FCU Obstructing Airflow**

1. Operate ventilation systems that are designed for heating/cooling continuously and in their appropriate modes during periods of occupancy.
2. Remove all blockages from FCUs and operate to facilitate airflow.

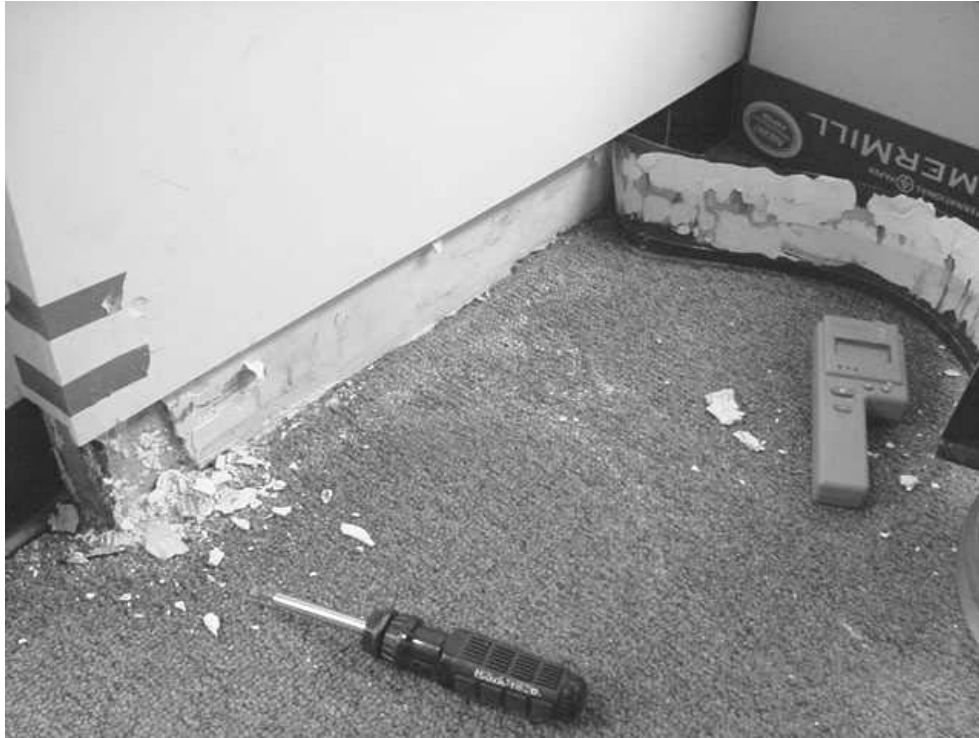
**Picture 5**

As a result of plumbing leaks in the Tax Collectors office, sections of water damaged wall plaster were replaced. CEH staff removed the vinyl coving at the base of the wall to inspect wall plaster and observed visible mold growth (Pictures 5 and 6). In addition, CEH staff conducted moisture testing of water damaged wall plaster. In order for building materials to support mold growth, a source of water exposure is necessary. Identification and elimination of water moistening building materials is necessary to control mold growth (in this case a plumbing leak). Materials with increased moisture content *over normal* concentrations may indicate the possible presence of mold growth. At the time of the assessment the wall plaster behind the coving was found to have an elevated (i.e., saturated) moisture content when compared to uncovered plaster walls (Table 1). The vinyl coving serves as an impermeable barrier that traps moisture behind it, preventing wet materials from drying. Carpeting tested in this area was found to have low (i.e., normal) moisture content (Table 1), at the time of the assessment.

**Water Damaged Wall Plaster and Visible Mold Growth behind Vinyl Coving (Removed by CEH staff)  
In Tax Collectors Office**

7. Replace all water damaged/mold colonized wall plaster in the Tax Collector's office. This measure will remove actively growing mold colonies that may be present. Remove carpeting in this area to inspect for mold growth. This work should be conducted at a time when occupants are not present in the area. Once work is completed, ensure that the area is thoroughly cleaned and disinfected with an appropriate antimicrobial. Renovation generated dust and particulates in carpeted areas should be vacuumed with a HEPA filtered vacuum cleaner.

8. Mold remediation should be conducted in a manner consistent with recommendations in "Mold Remediation in Schools and Commercial Buildings" published by the US Environmental Protection Agency (US EPA, 2001). This document can be downloaded from the US EPA website at:  
[http://www.epa.gov/iaq/molds/mold\\_remediation.html](http://www.epa.gov/iaq/molds/mold_remediation.html).

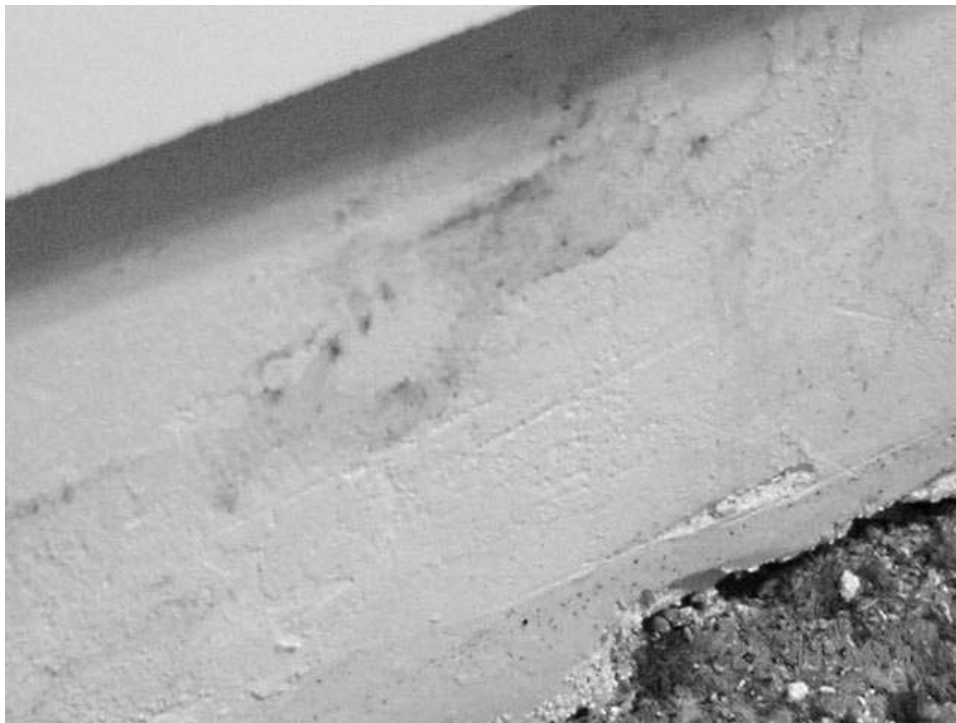
**Picture 6**

**Close-up of Water Damaged Wall Plaster and Visible Mold Growth behind Vinyl Coving (Removed by  
CEH staff) In Tax Collectors Office**

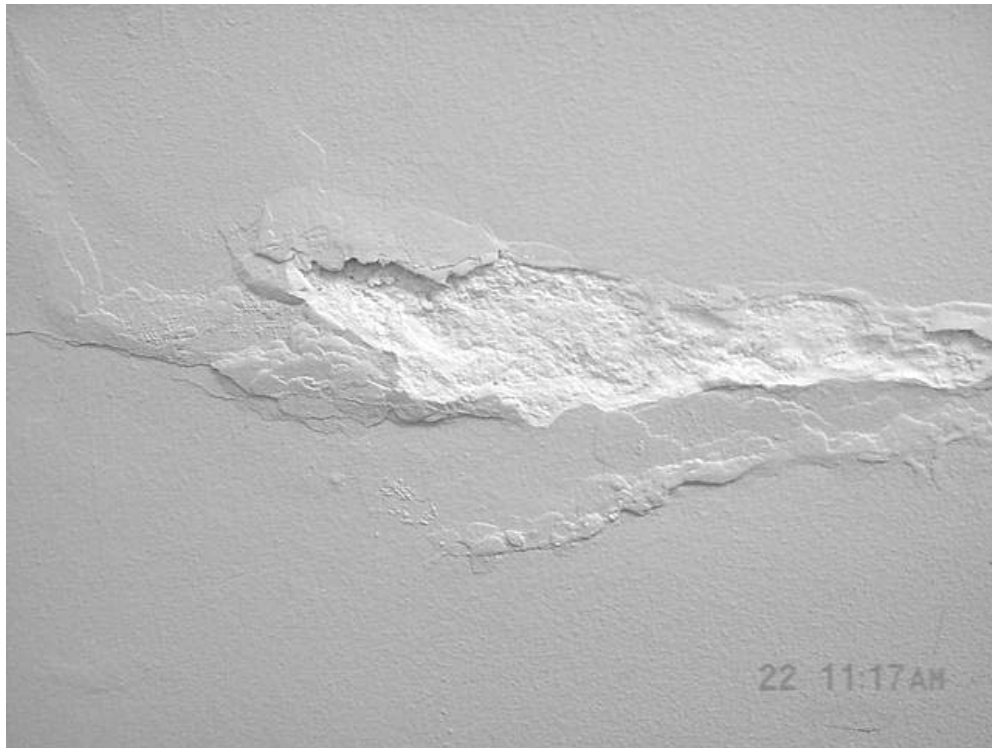
**Picture 7**

Water damaged wall plaster and efflorescence were observed in the Town Clerk's (Picture 7) and Town Manager's offices. At the time of the assessment these areas were found to have low (i.e., normal) moisture content (Table 1). Water damage is most likely the result of water penetration through the building envelope. Efflorescence is a characteristic sign of water damage to brick and mortar, but it is not mold growth. As moisture penetrates and works its way through mortar and brick, water-soluble compounds in mortar and brick dissolve, creating a solution. As the solution moves to the surface of the mortar or brick, the water evaporates, leaving behind white, powdery mineral deposits. During a perimeter inspection of the building, missing/damaged mortar around exterior brickwork was observed in several areas (Pictures 8 and 9).

**Peeling Paint and Efflorescence in Town Clerks Office**

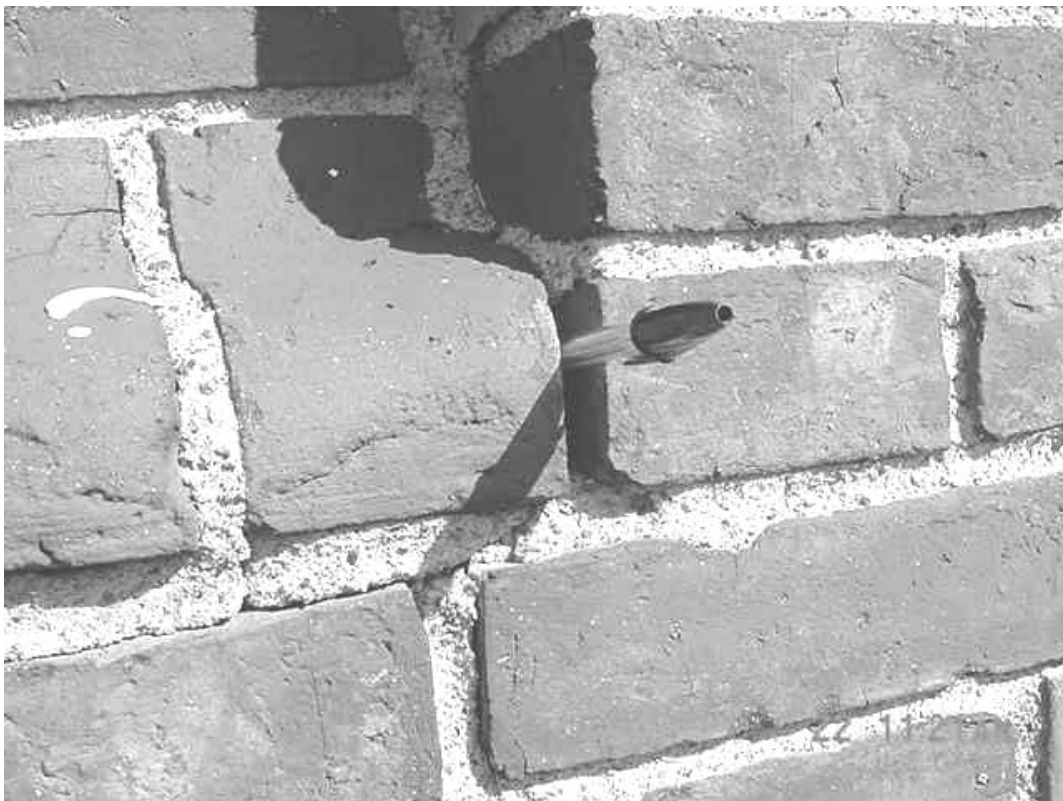
**Picture 8**

**Missing/Damaged Mortar around Brick, Pen Inserted by CEH Staff to Show Depth**

10. Contact a masonry firm or general contractor to repair holes/breaches in exterior walls to prevent water penetration, drafts and pest entry.
11. Ensure all plants are equipped with drip pans. Examine drip pans for mold growth and disinfect areas of water leaks with an appropriate antimicrobial where necessary. Move plants away from ventilation sources.

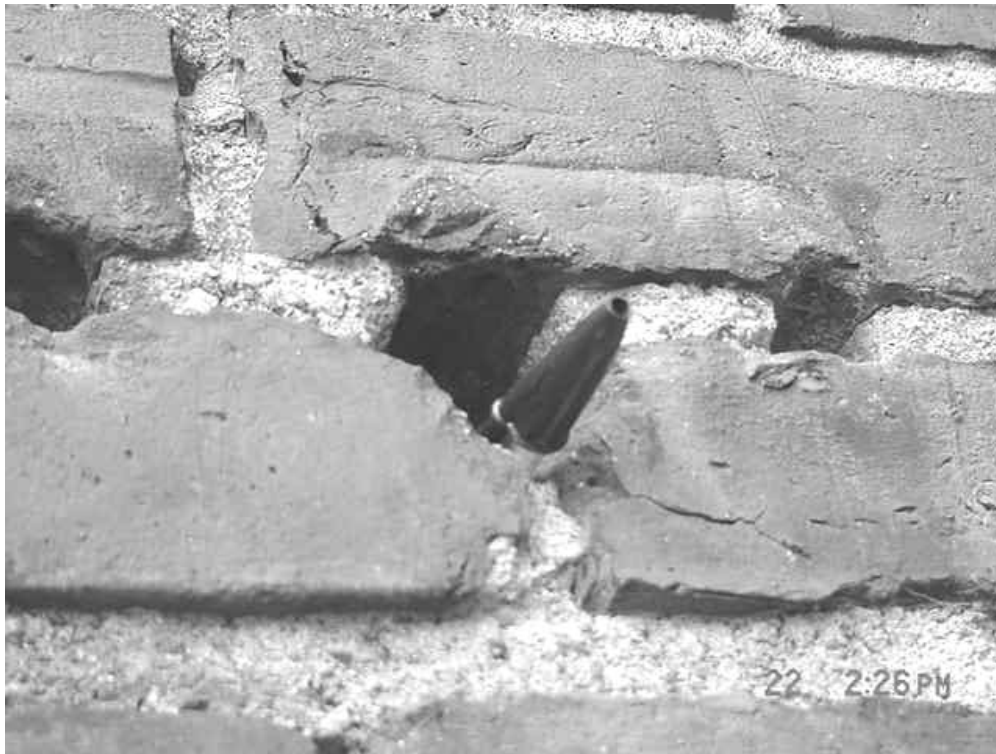
**Picture 9**

**Missing/Damaged Mortar around Brick, Pen Inserted by CEH Staff to Show Depth**

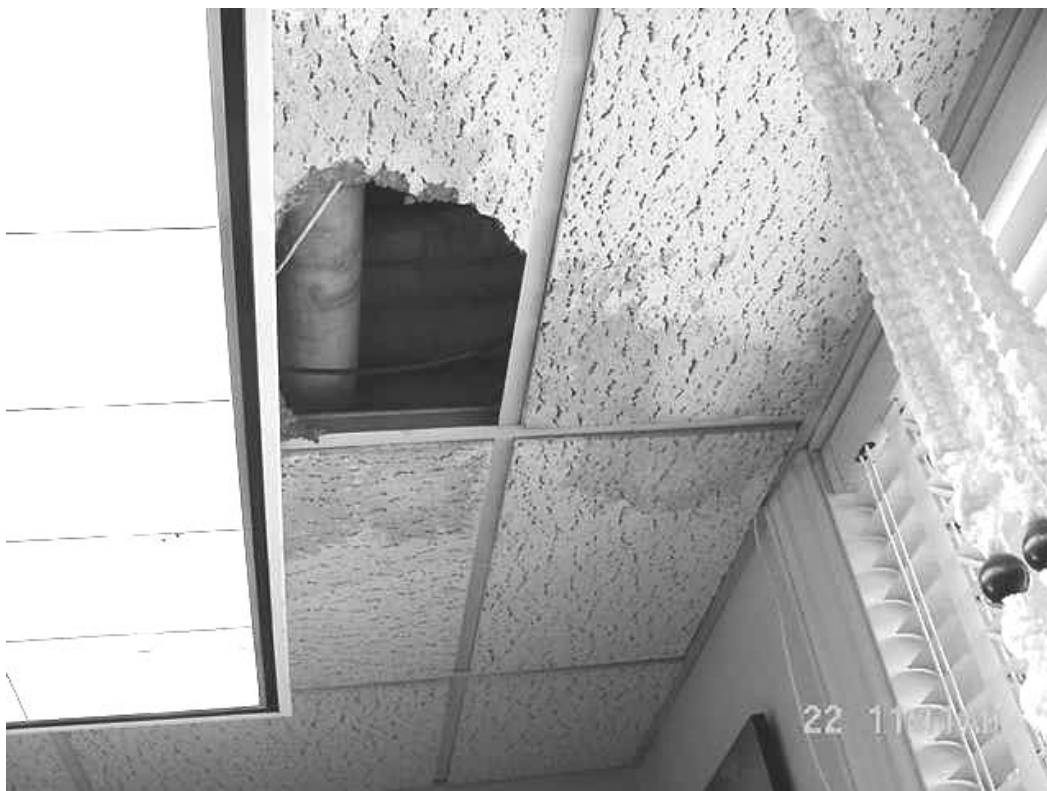
**Picture 10**

A number of areas had water damaged ceiling tiles (Picture 10), which can indicate leaks from the roof or plumbing system. Water damaged ceiling tiles can provide a source of mold and should be replaced after a water leak is discovered and repaired.

**Water Damaged Ceiling Tiles**

9. Replace/repair any remaining water-stained ceiling tiles. Examine the area above and around these areas for mold growth. Disinfect areas of water leaks with an appropriate antimicrobial.

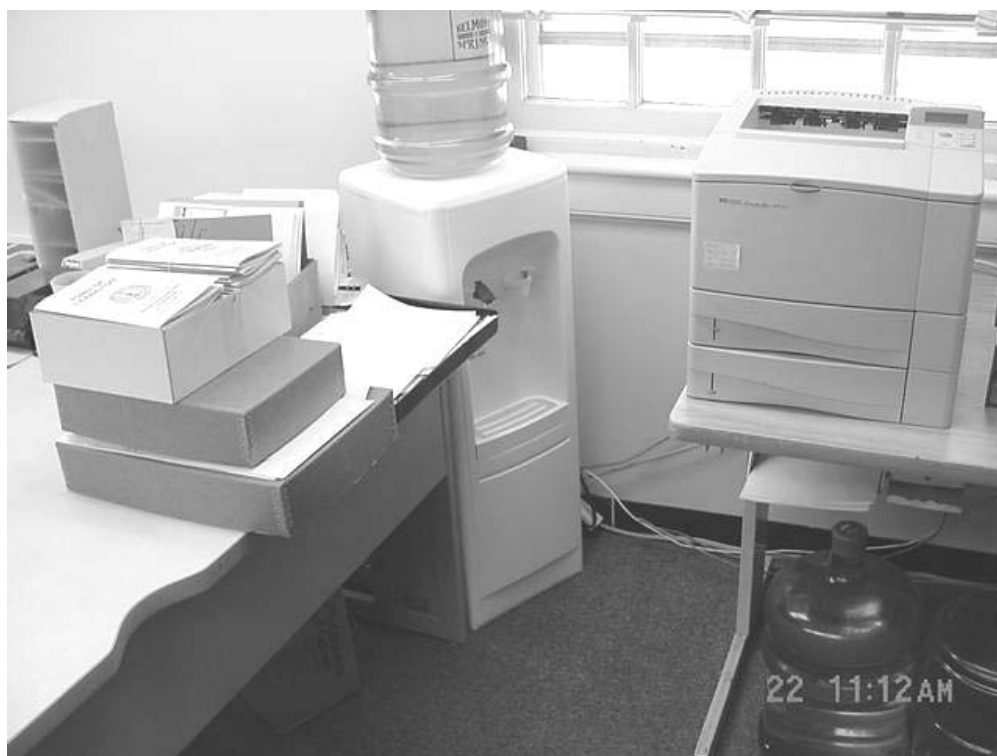
**Picture 11**

Water coolers were located over carpeting (Picture 11) in some areas. Water spillage or overflow of cooler catch basins can result in the wetting of the carpet. In addition, some of the coolers had residue/build-up in the reservoir. These reservoirs are designed to catch excess water during operation and should be emptied/cleaned regularly to prevent microbial and/or bacterial growth.

**Water Cooler on Carpeting**

12. Relocate or place tile or rubber matting underneath water coolers in carpeted areas.  
Clean and disinfect reservoirs as needed to prevent microbial growth.

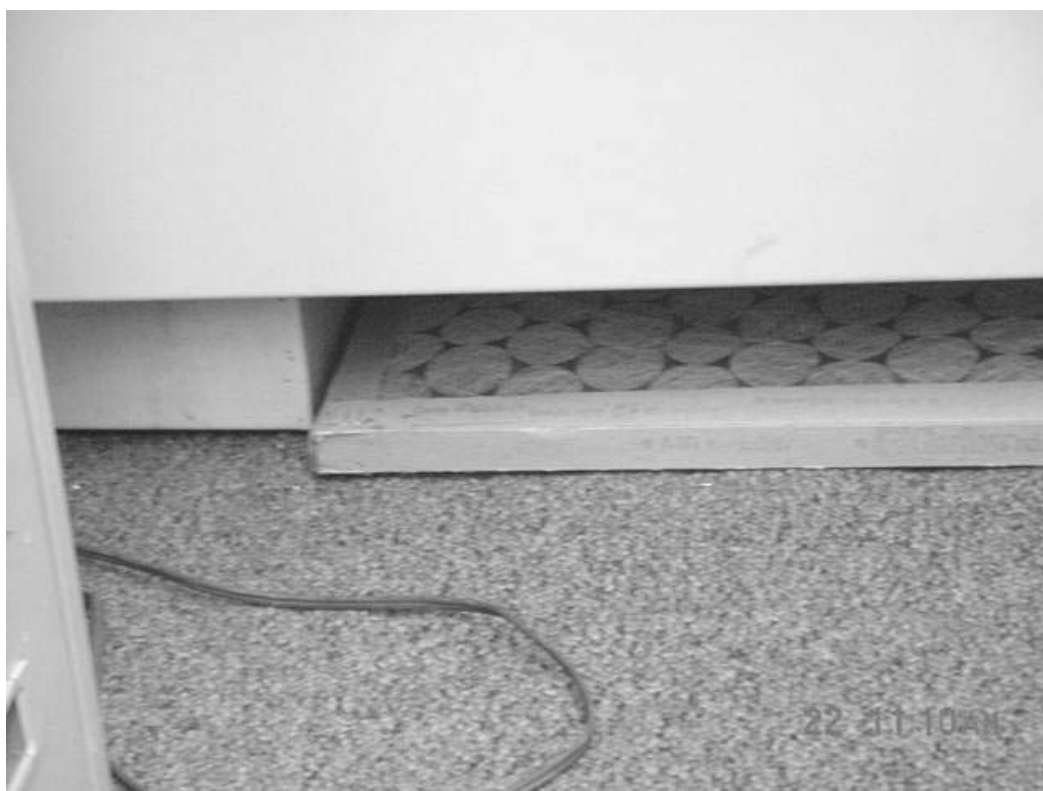
**Picture 12**

**Air Filter on Floor beneath FCU**

13. Contact the manufacture of FCUs or HVAC engineering firm to determine appropriate size and installation of filters.
14. Change filters for air-handling equipment as per the manufacturer's instructions or more frequently if needed. Vacuum interior of units prior to activation to prevent the aerosolization of dirt, dust and particulates. Ensure filters fit flush in their racks with no spaces in between allowing bypass of unfiltered air into the units.

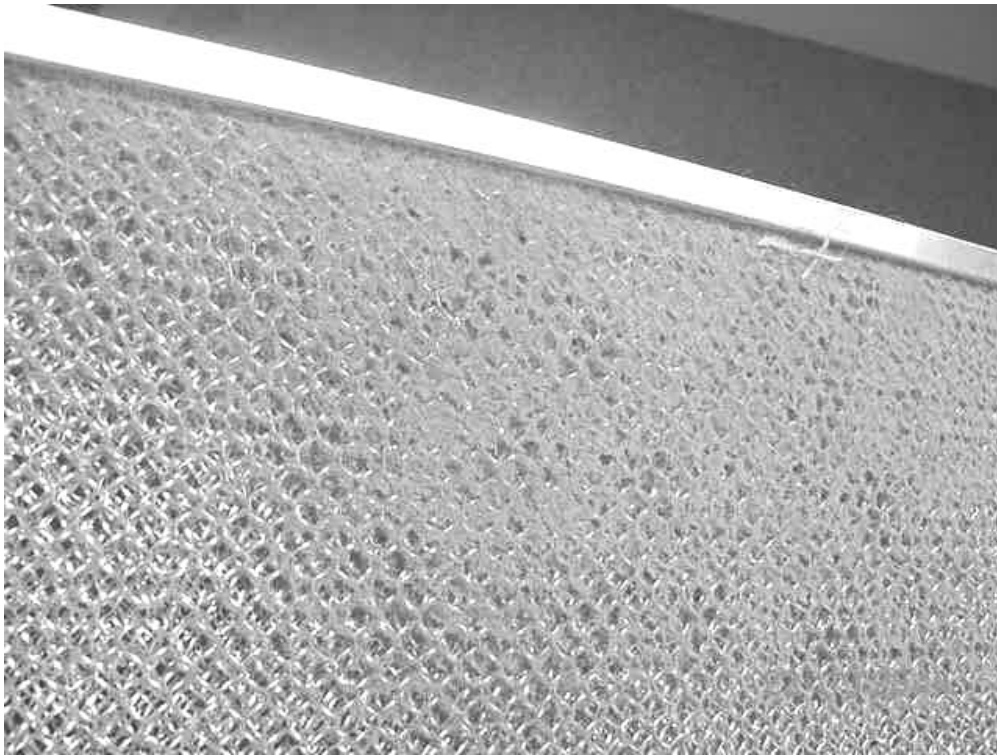
**Picture 13**

The filters installed in the AHUs and FCUs at the LTH are of a type that provides minimal filtration (Pictures 13, 17 and 18). In order to decrease aerosolized particulates, higher efficiency, disposable filters can be installed in AHUs and FCUs. The dust spot efficiency is the ability of a filter to remove particulates of a certain diameter from air passing through the filter. Filters that have been determined by ASHRAE to meet its

**Metal/Mesh Filter with Accumulated Dust**

15. Consider upgrading to higher efficiency pleated filters.
16. Consider installing hatchway for easier access for maintenance of attic AHUs.
17. Seal utility holes in floors of FCU cabinets as well as other areas of the building (Picture 22) to prevent the migration of odors.

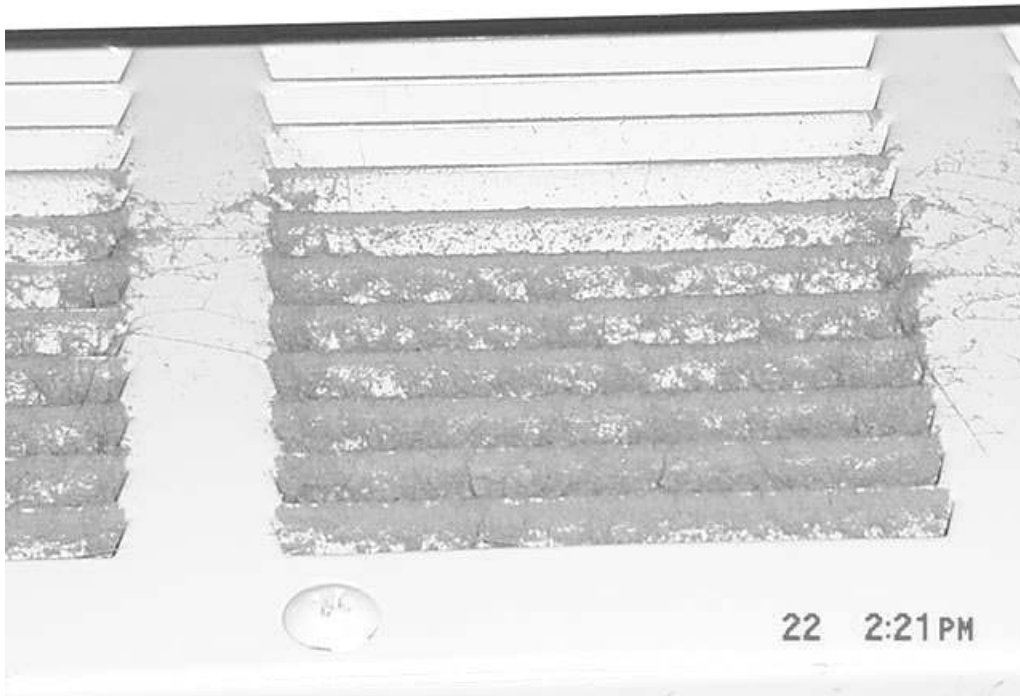
**Picture 14**

**Dust Accumulation on FCU Air Diffuser**

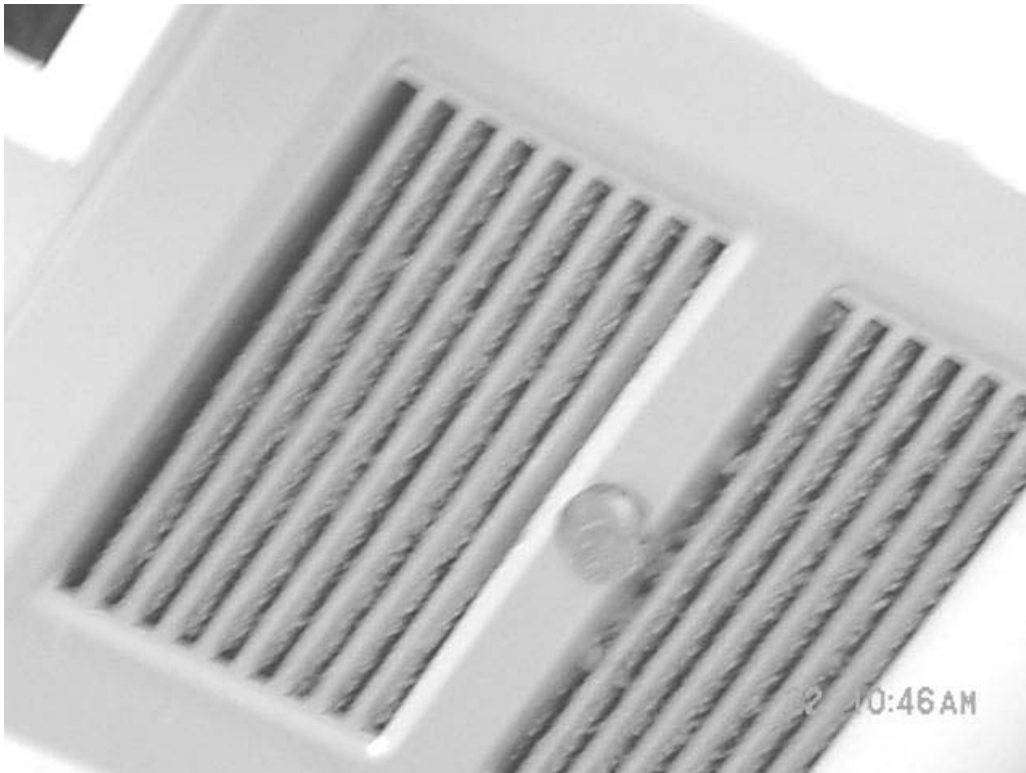
**Picture 15**

**Accumulated Dust on Exhaust Vent**

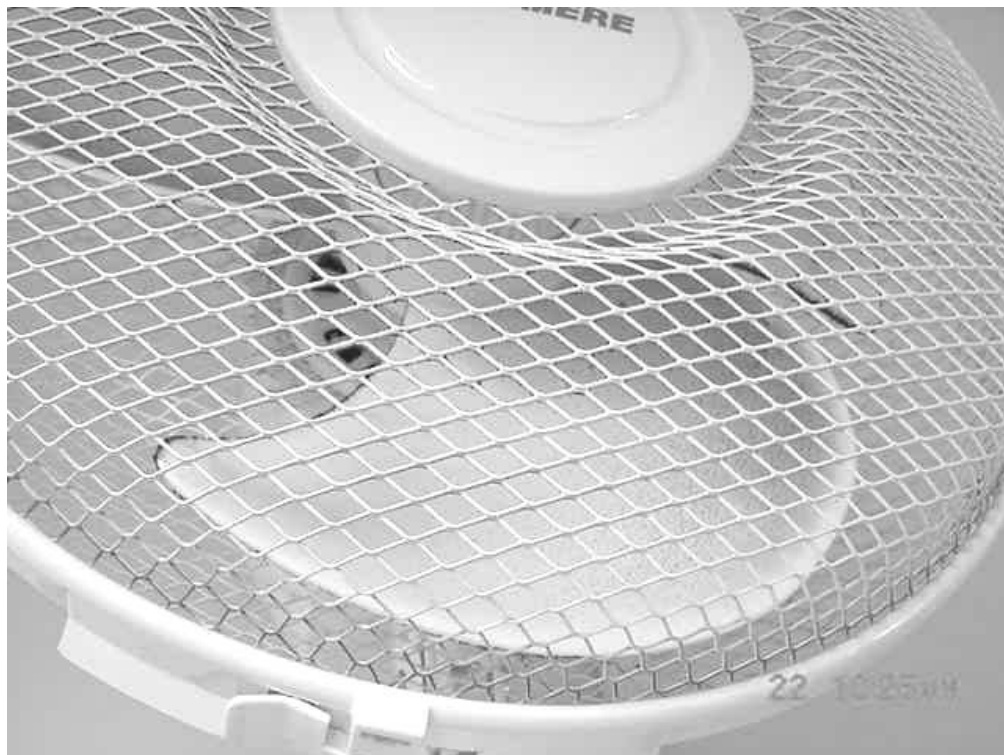
**Picture 16**

**Accumulated Dust on Fan Blades**

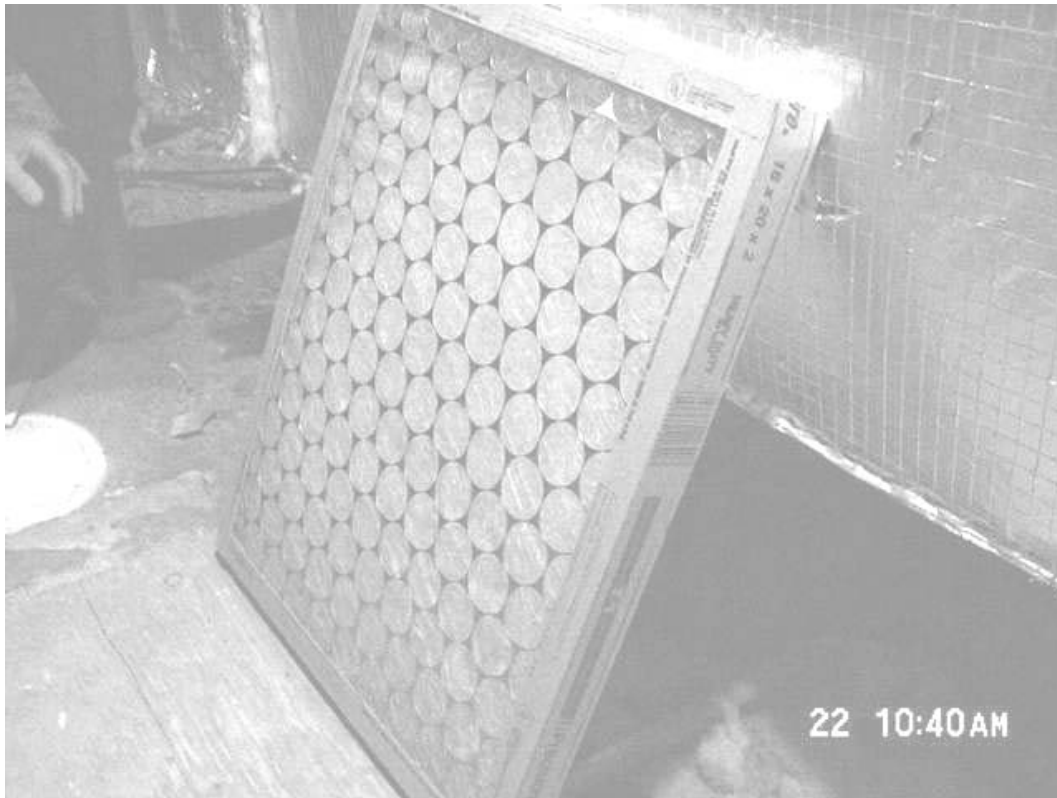
**Picture 17**

**Fiberglass/Mesh (Low Efficiency) Filter in Attic AHU**

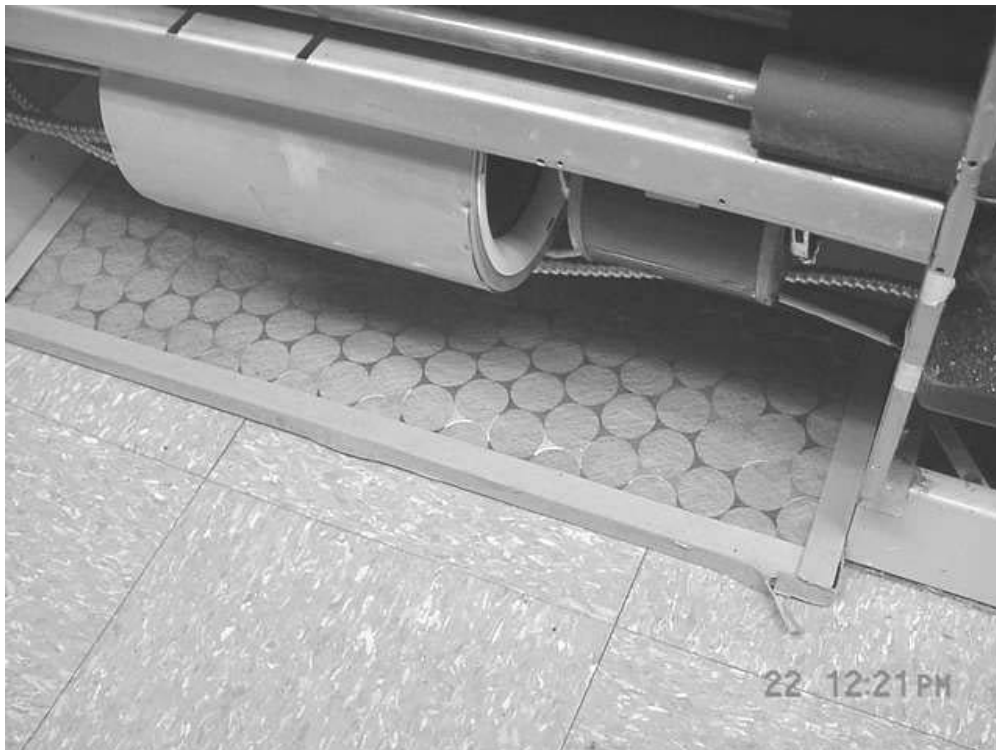
**Picture 18**

**Fiberglass/Mesh (Low Efficiency) Filter in Attic AHU**

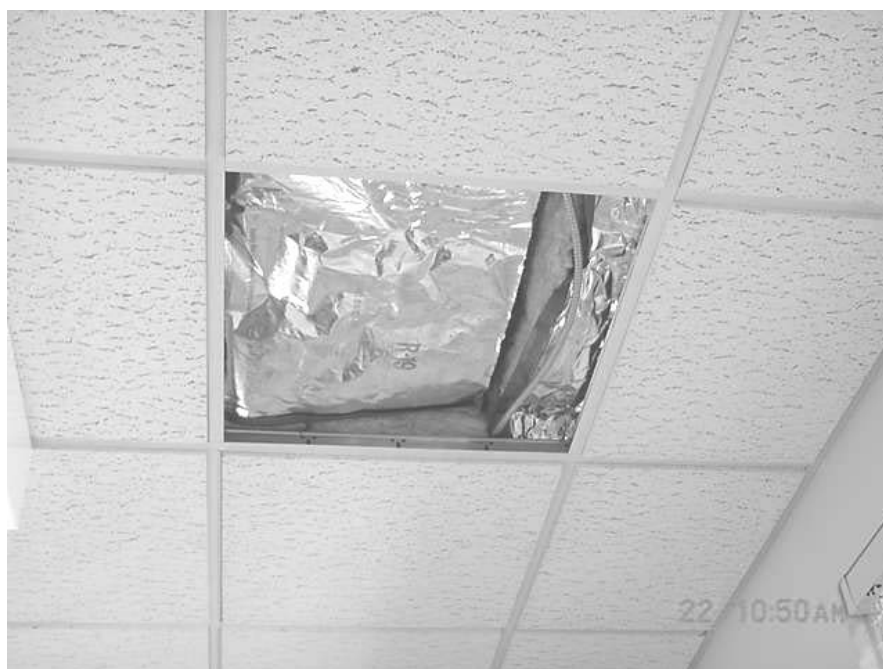
**Picture 20**

Lastly, exposed fiberglass insulation was observed around pipes and above missing ceiling tiles (Pictures 20 and 21). Fiberglass insulation can provide a source of skin, eye and respiratory irritation.

**Missing Ceiling Tile Exposing Fiberglass Insulation**

20. Wrap heating pipes and replace missing/damaged ceiling tiles to prevent exposure to fiberglass insulation and other particulates.
21. Relocate or consider reducing the amount of materials stored in offices and common areas to allow for more thorough cleaning. Clean items regularly with a wet cloth or sponge to prevent excessive dust build-up.

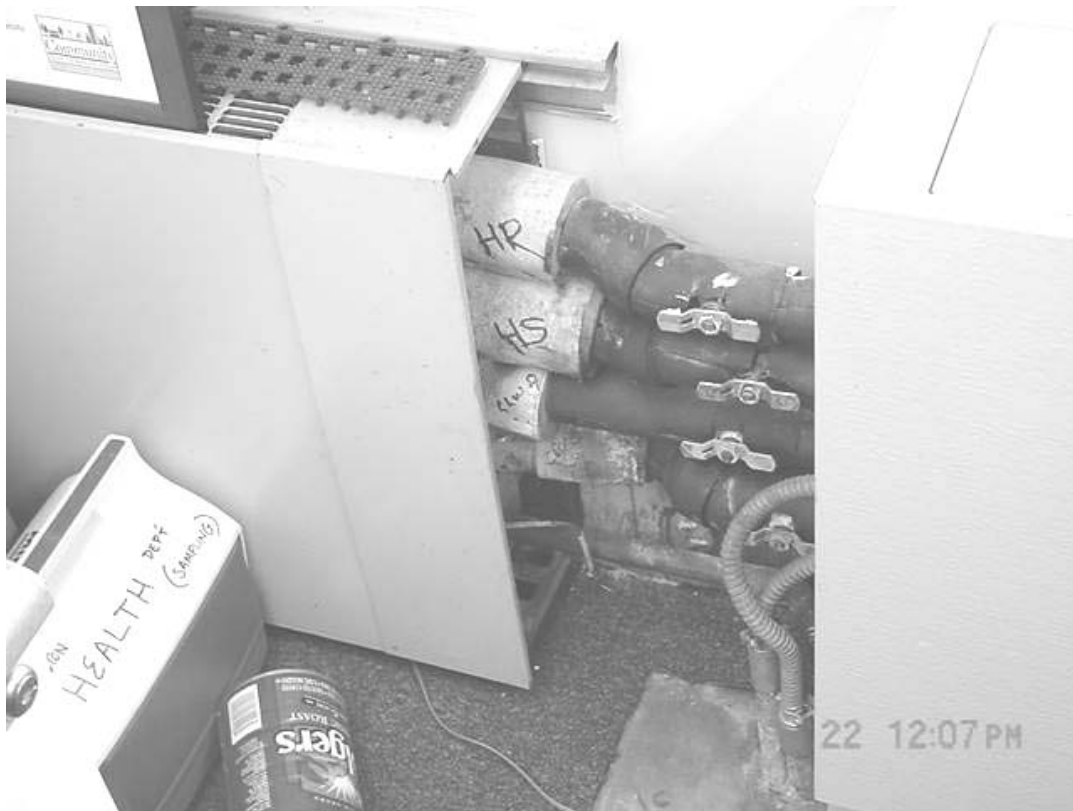
**Picture 21**

**Exposed Fiberglass Pipe Insulation**

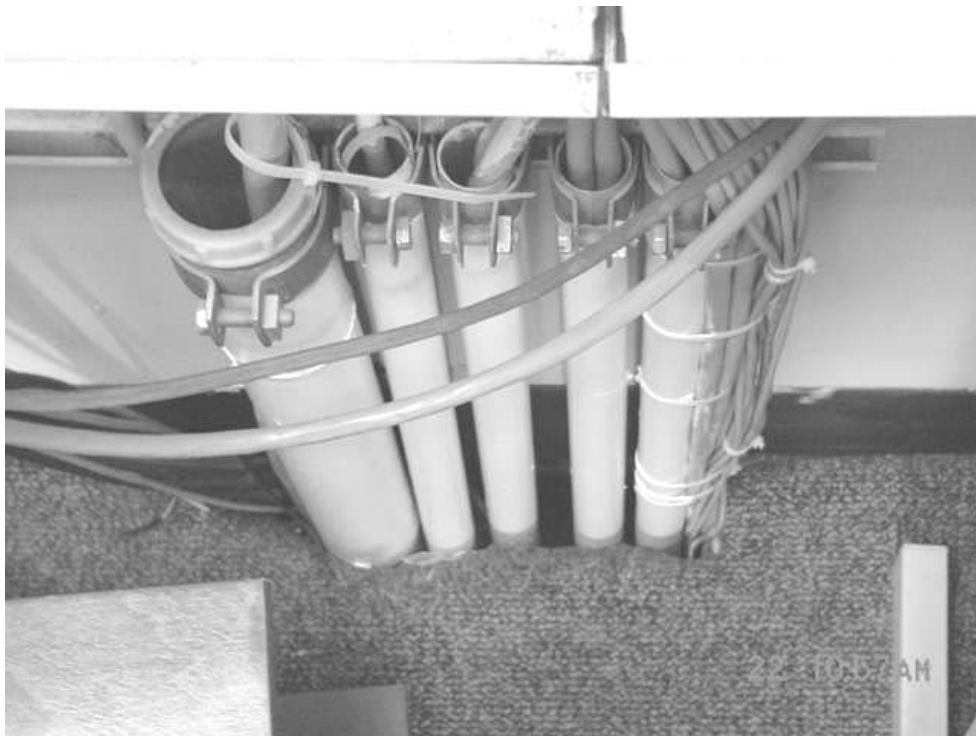
**Picture 22**

**Open Pipes and Utility Hole in Floor**
